## STABILIZATION OF LOWRY RUINS

ADRIAN S. WHITE  
AND  
DAVID A. BRETERNITZ

Mesa Verde Research Center  
University of Colorado  
Boulder, Colorado

March 1976

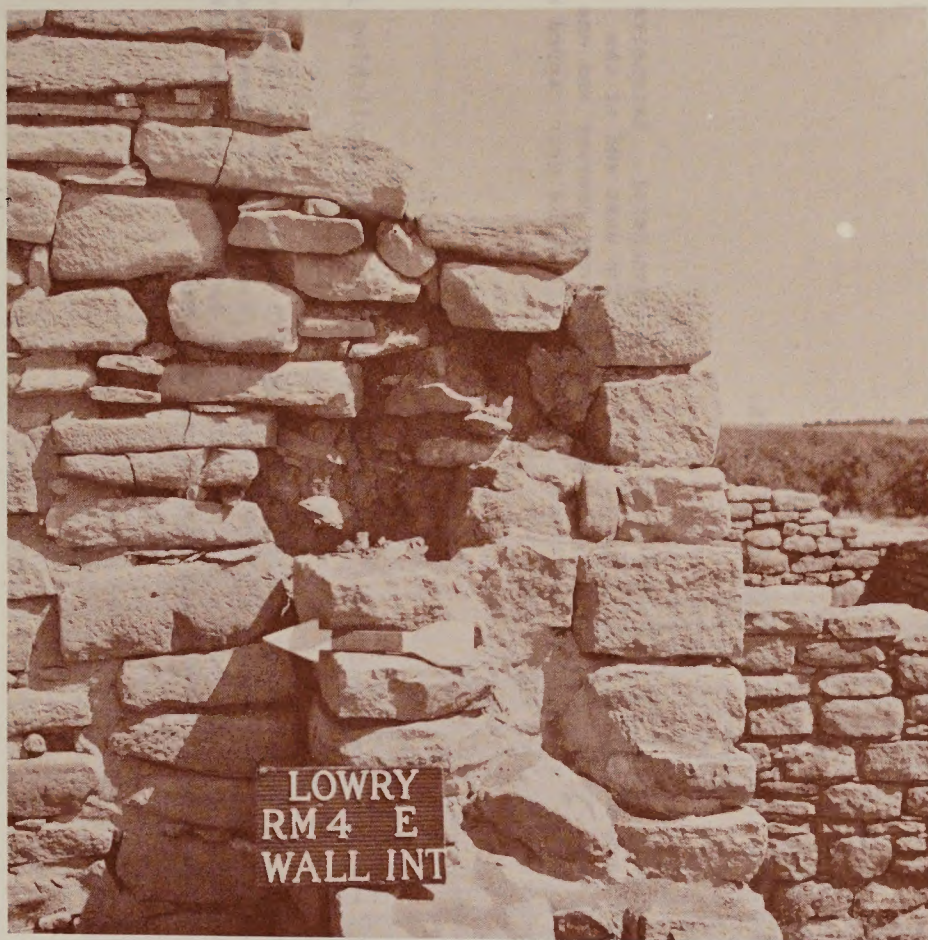
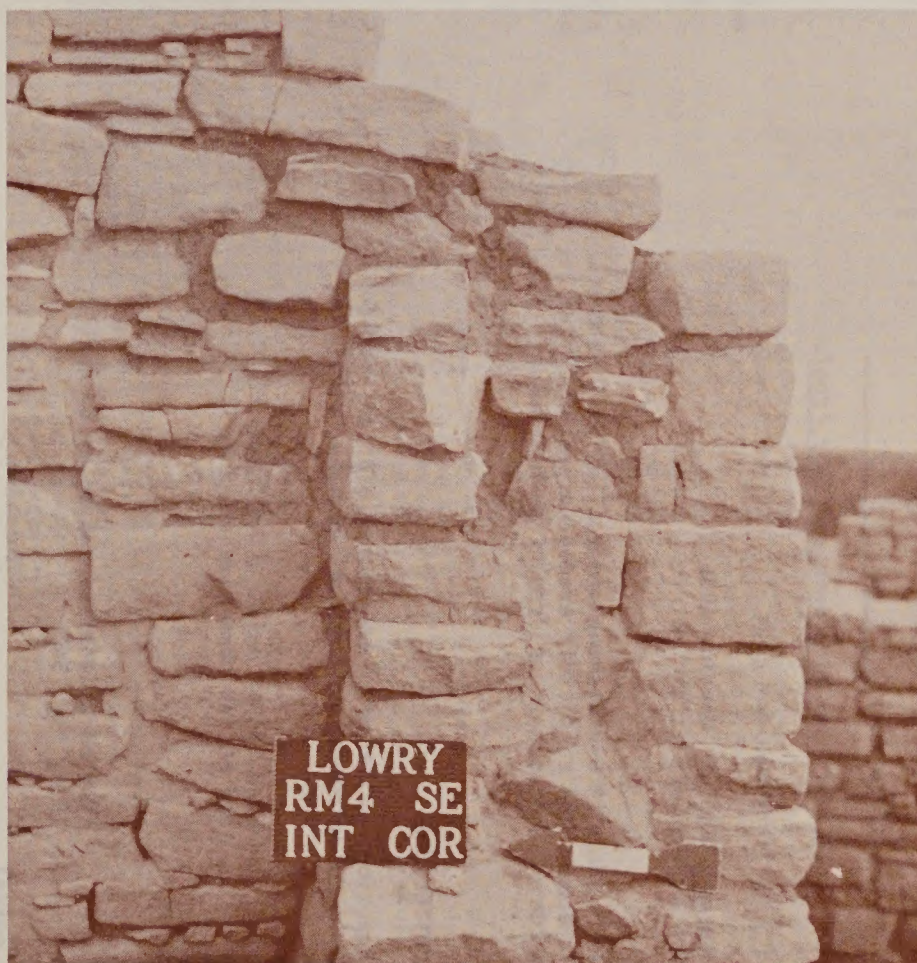
Figure 59. Room 4, southeast interior corner. a, several stones slipped from wall leaving a large gap; b, stones were reset.

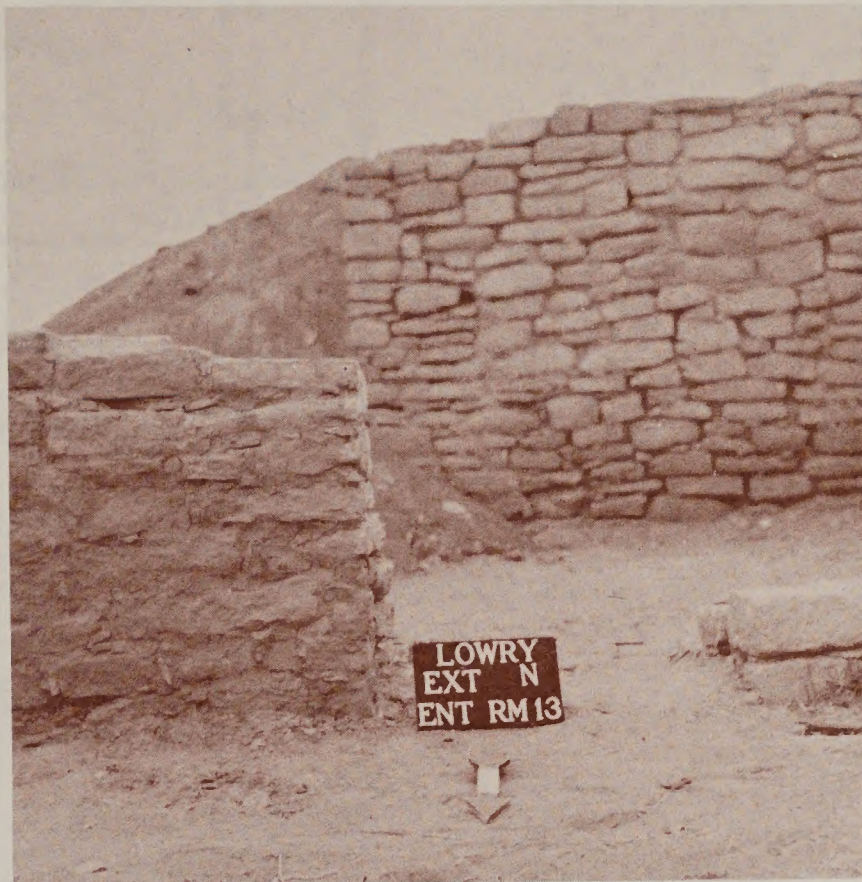
Figure 60. Room 13, north exterior entrance. Several stones were reset on the west side of the entrance. No photo was taken before stabilization.

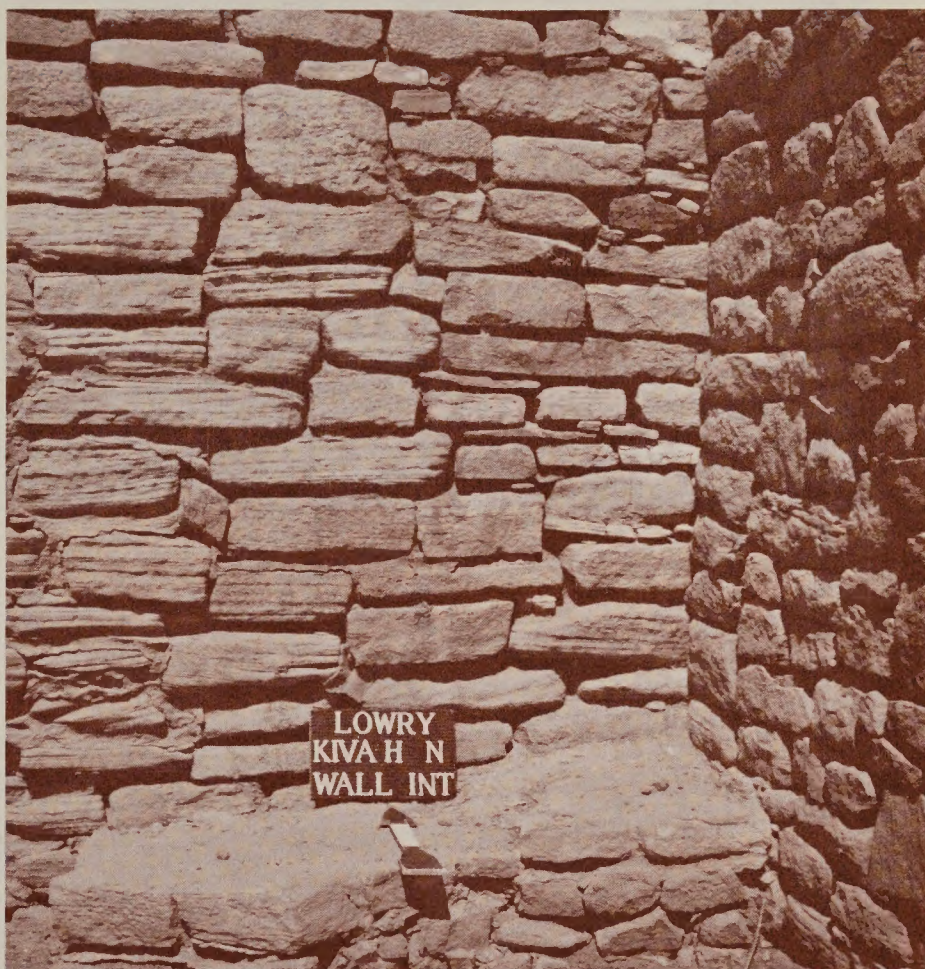
Figure 61. Kiva H, north interior wall. A small patch was made with soil mortar where two stones had slipped from the wall. No photo was taken before stabilization.

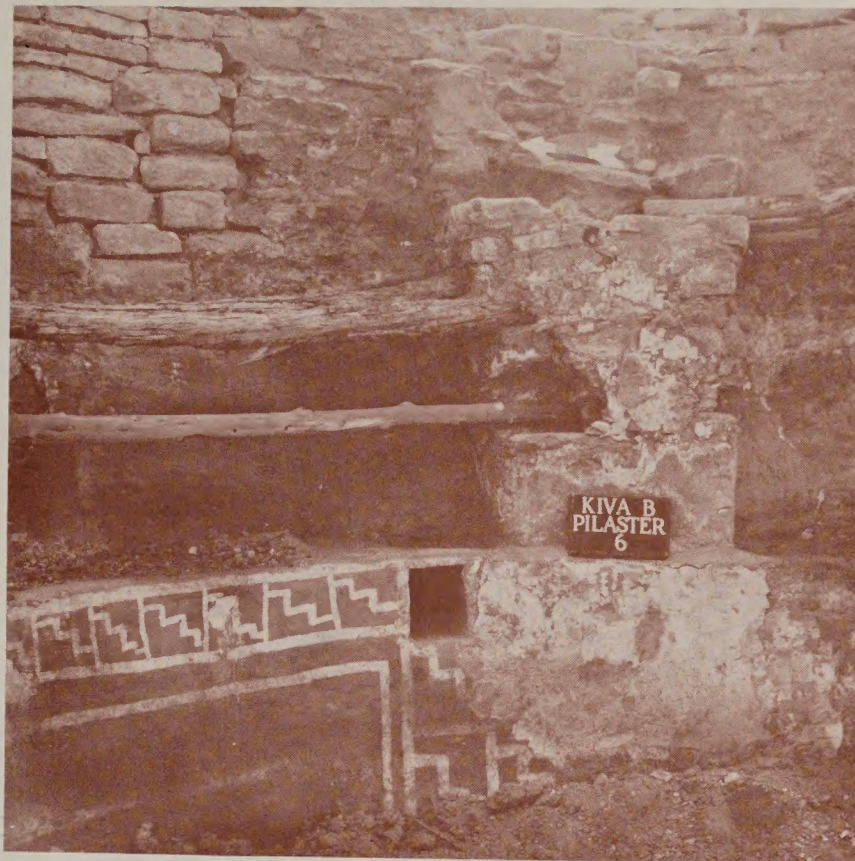
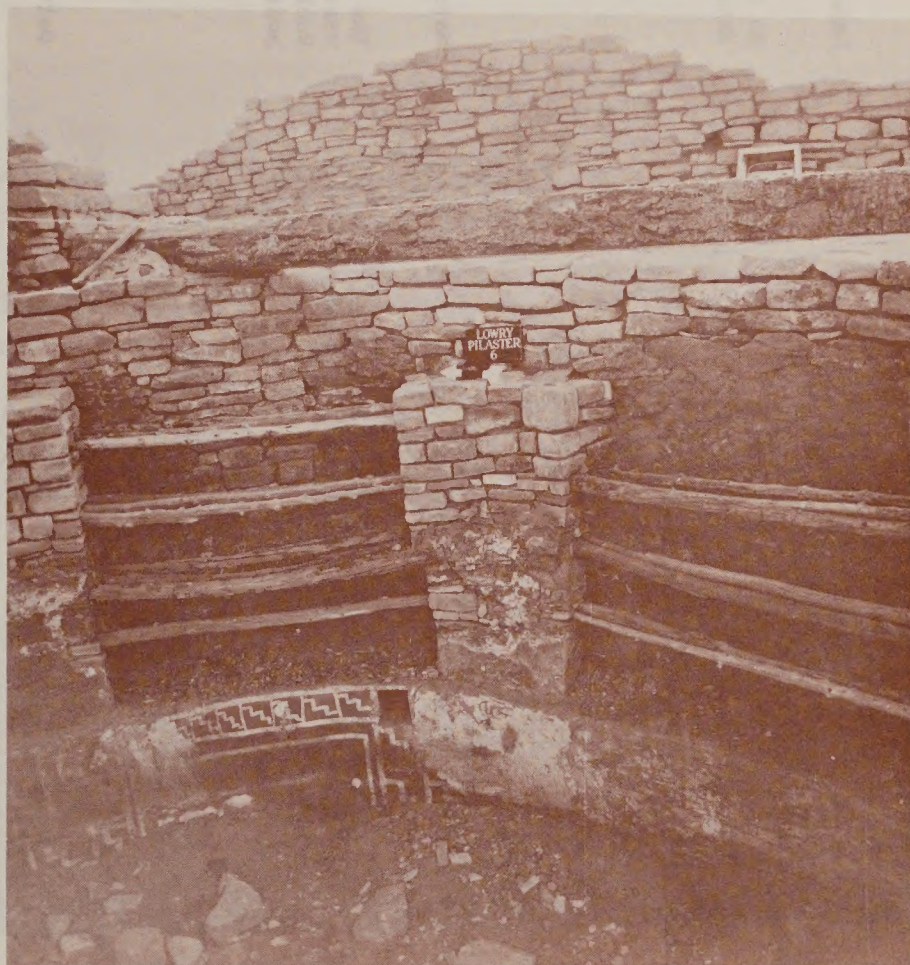
Figure 62. Kiva B, pilaster 6. a, before stabilization showing the extent of damage; b, after stabilization.

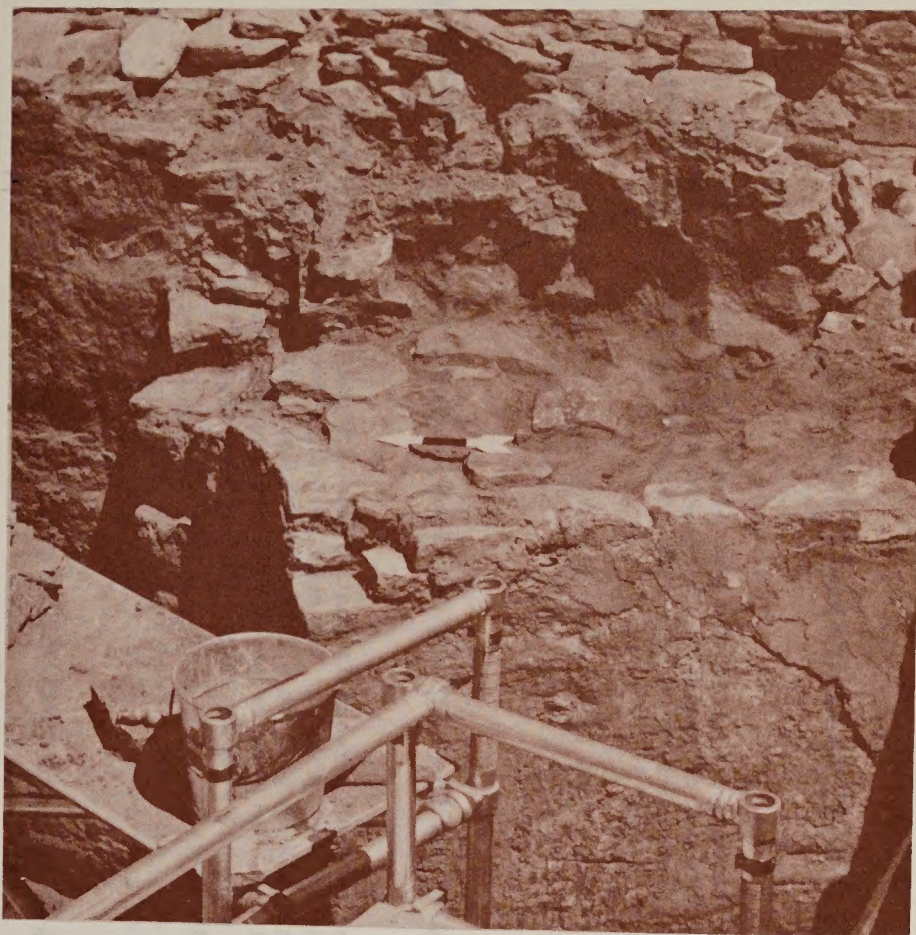
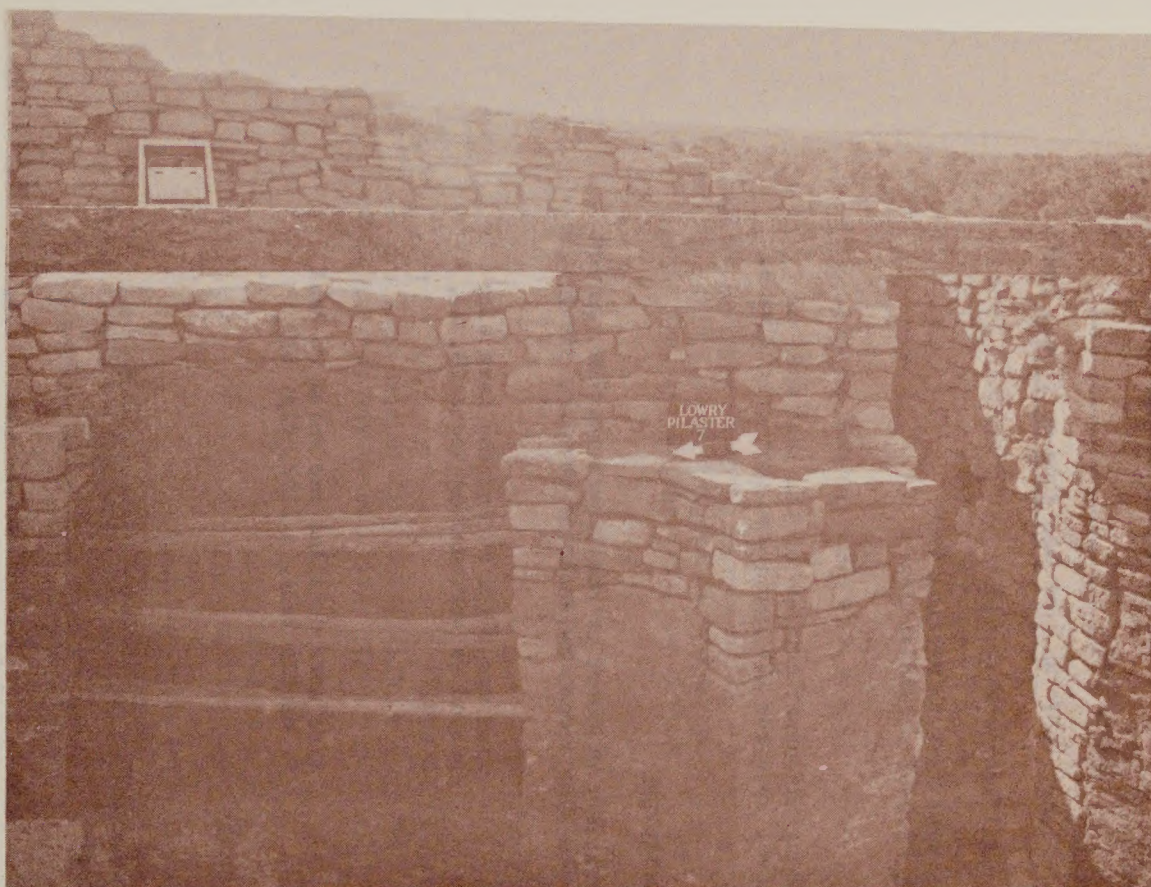
Figure 63. Kiva B, pilaster 7. a, before stabilization; b, after stabilization.

Prehistoric masonry for the E wall of Kiva B was in good condition with building stones set firmly in mortar. Mud mortar retained a hard rough texture. Lack of erosion is probably due to immediate backfilling in 1936. The masonry for this wall is very rough with a stone face interior and exterior with rubble fill.

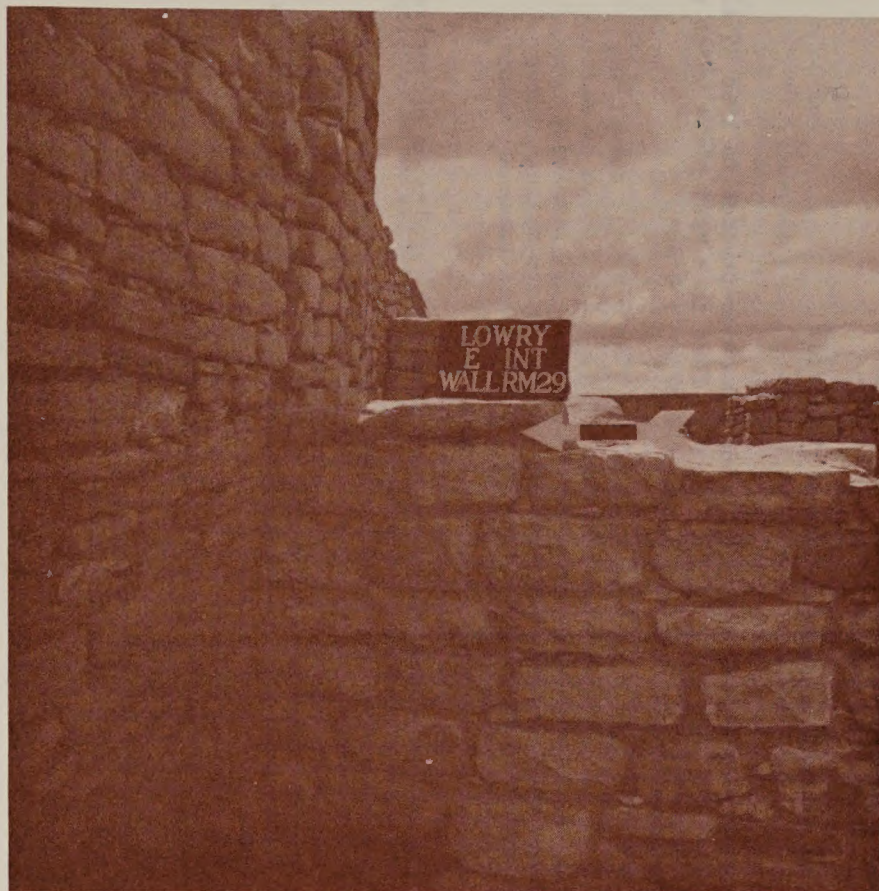
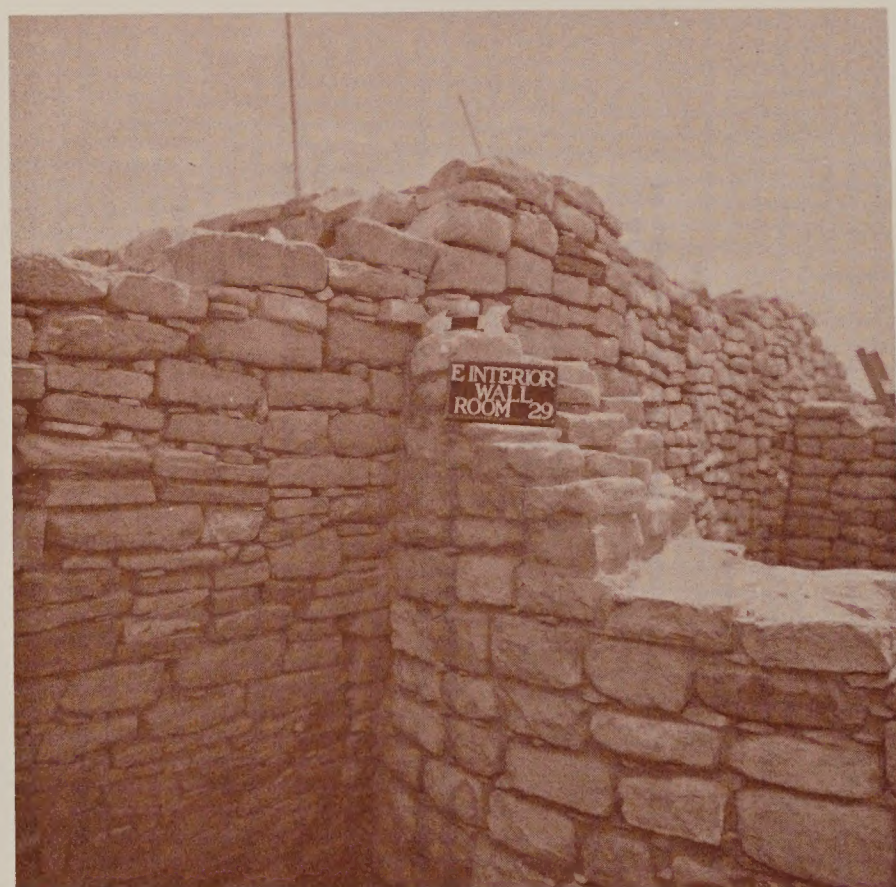
Figure 64. Room 29, east interior wall. a, view of wall before it was stepped up to brace the north wall; b, wall after courses were added.

The ancient masonry was in good condition in all areas except for the upper courses where the soil mortar was falling out and stones were loose and missing.

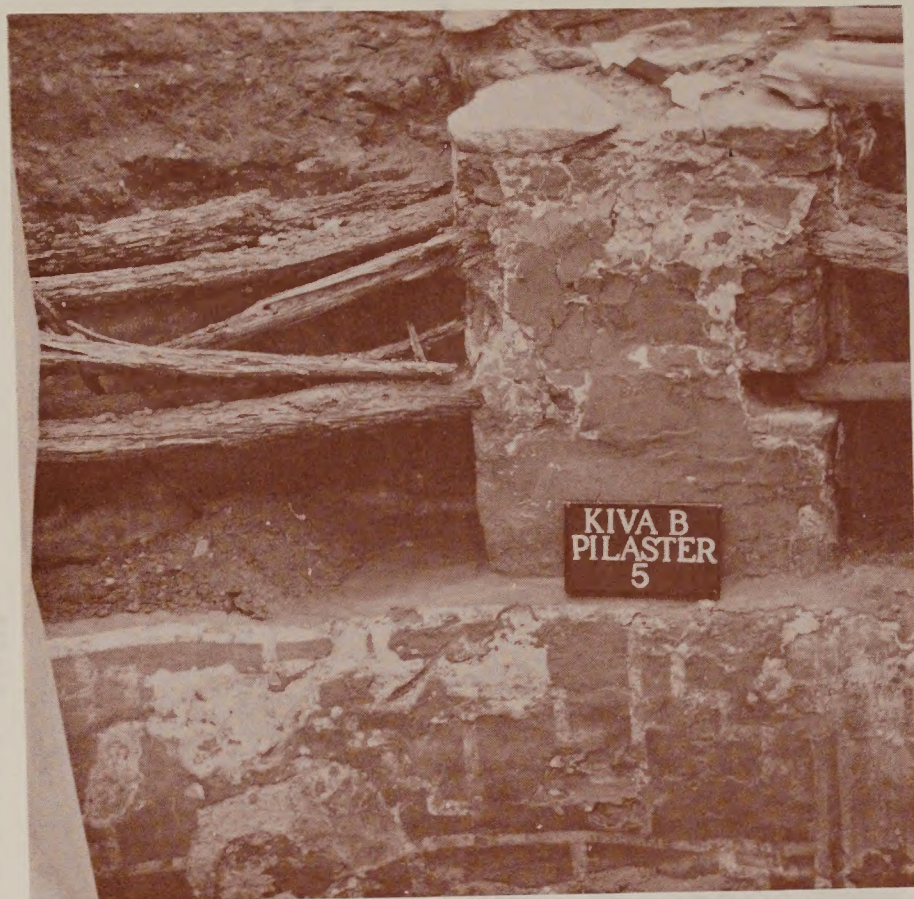
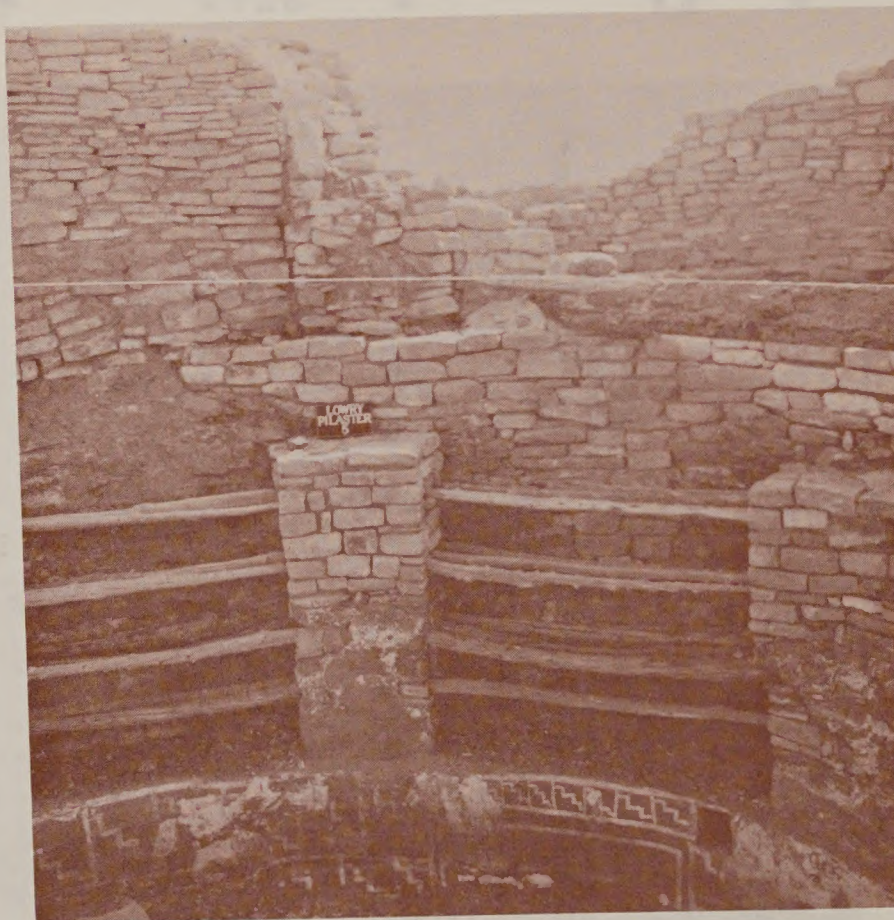
The upper portion of pilaster 5 had loose stones and mud mortar with stones missing in several areas. The pilaster needed to be rebuilt approx. 66 cm. to reach it's original height. Pilaster 5 was restored along with the rest of pilasters in Kiva B.

Figure 65. Kiva B, pilaster 5. a, pilaster before stabilization; b, about 66cm. was added to pilaster, also new shelves to either side of pilaster 5.

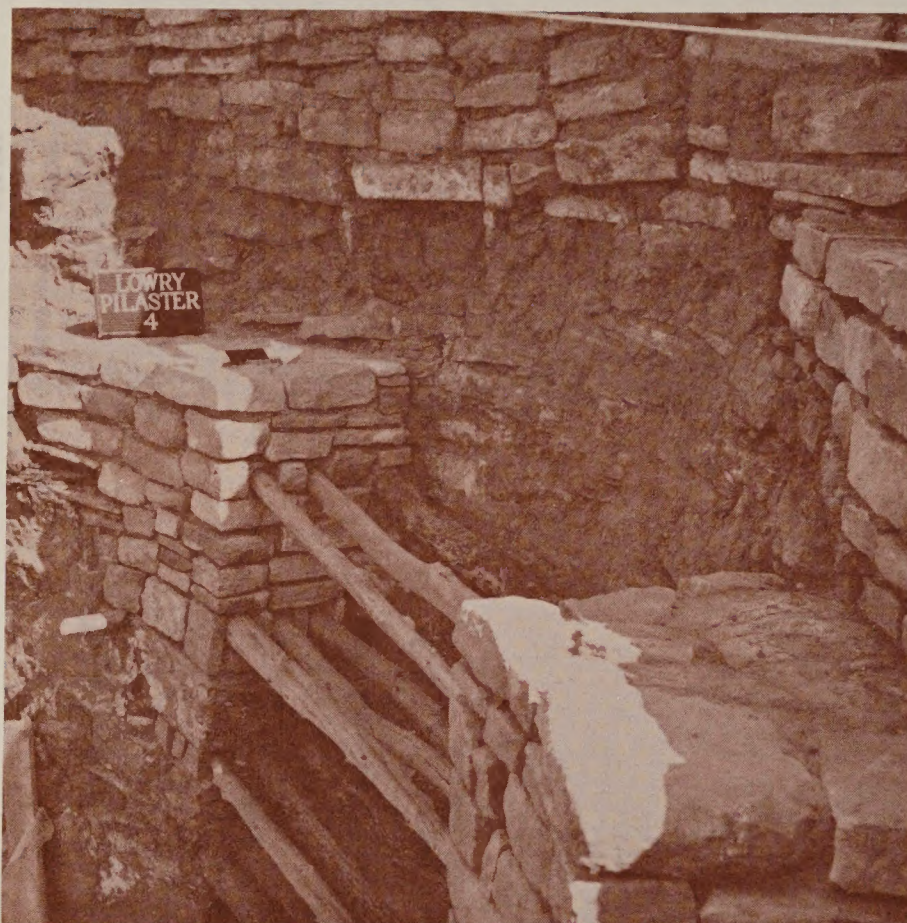
Figure 66. Kiva B, pilaster 4. Pilaster was stepped into the west wall of Kiva A. No photo was taken before stabilization.

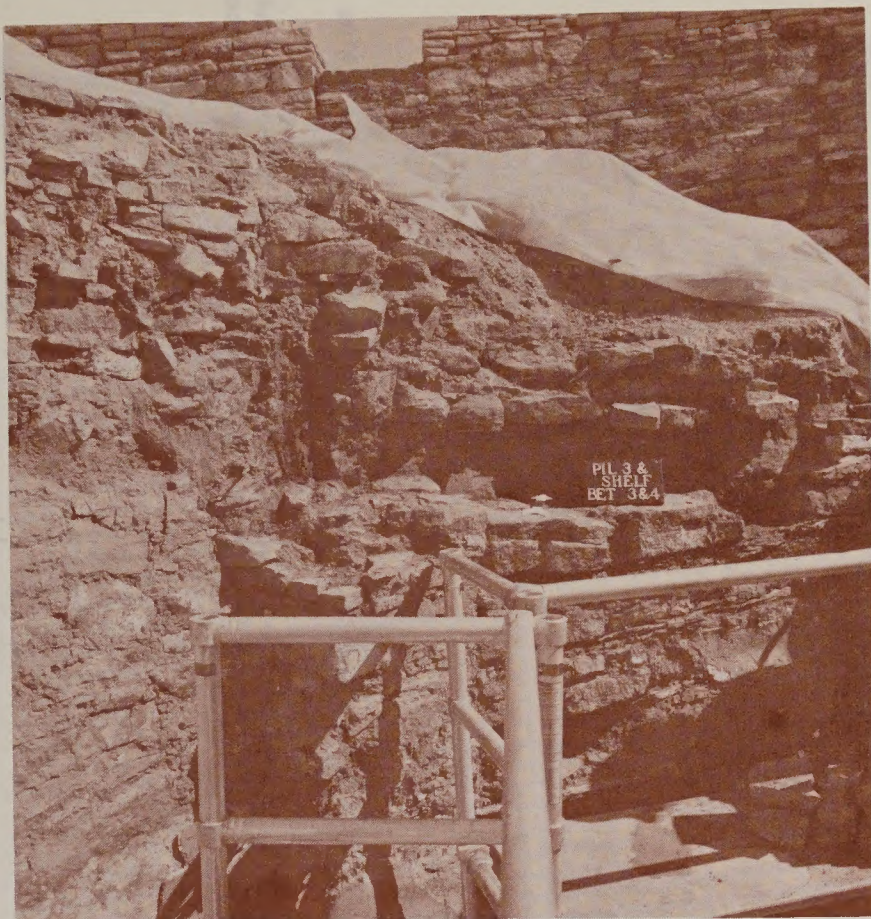
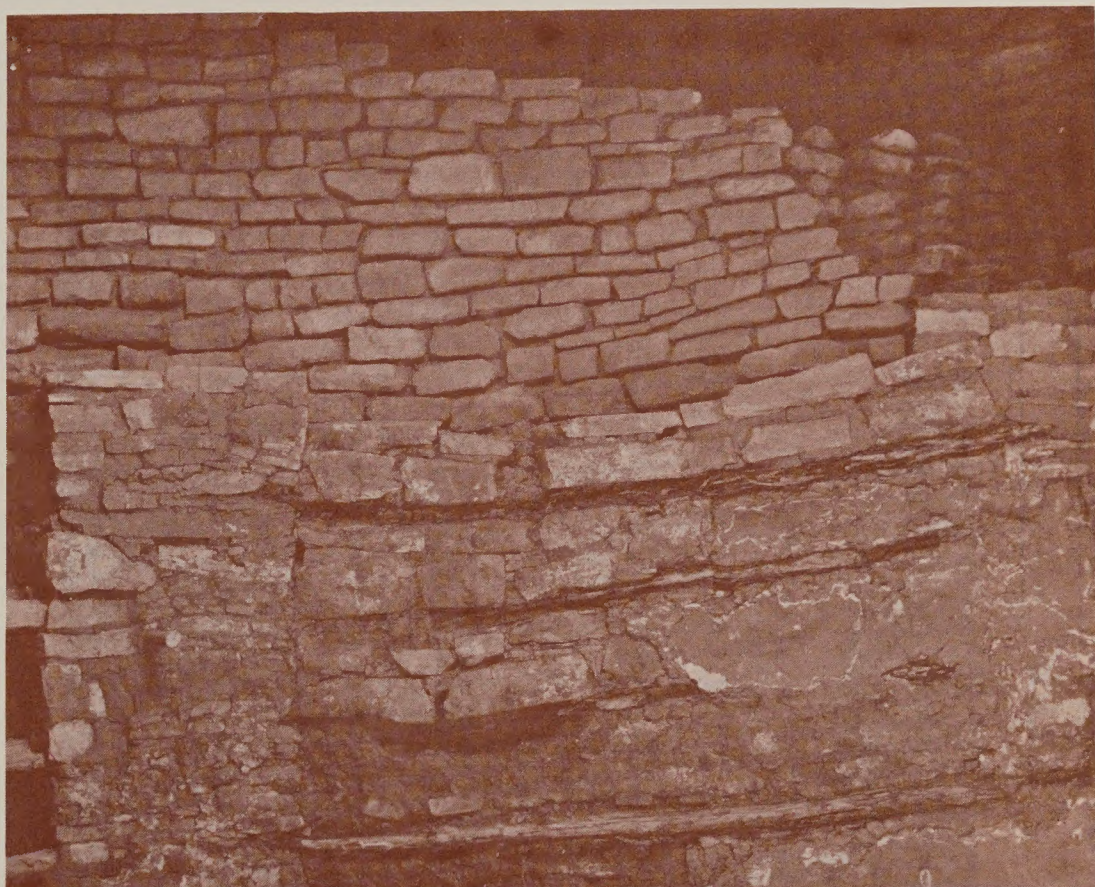
Much of the original pilaster was still in good shape retaining it's original shape. The area showing the most erosion was the front veneer of the pilaster, the damage did not extend through the thickness of pilaster. The upper 2 courses had to be reset the thickness of pilaster and the front veneer to a depth of 85 cm.

Figure 67. Kiva B, pilaster 3. a, before stabilization; b, after stabilization and painting of the joints.

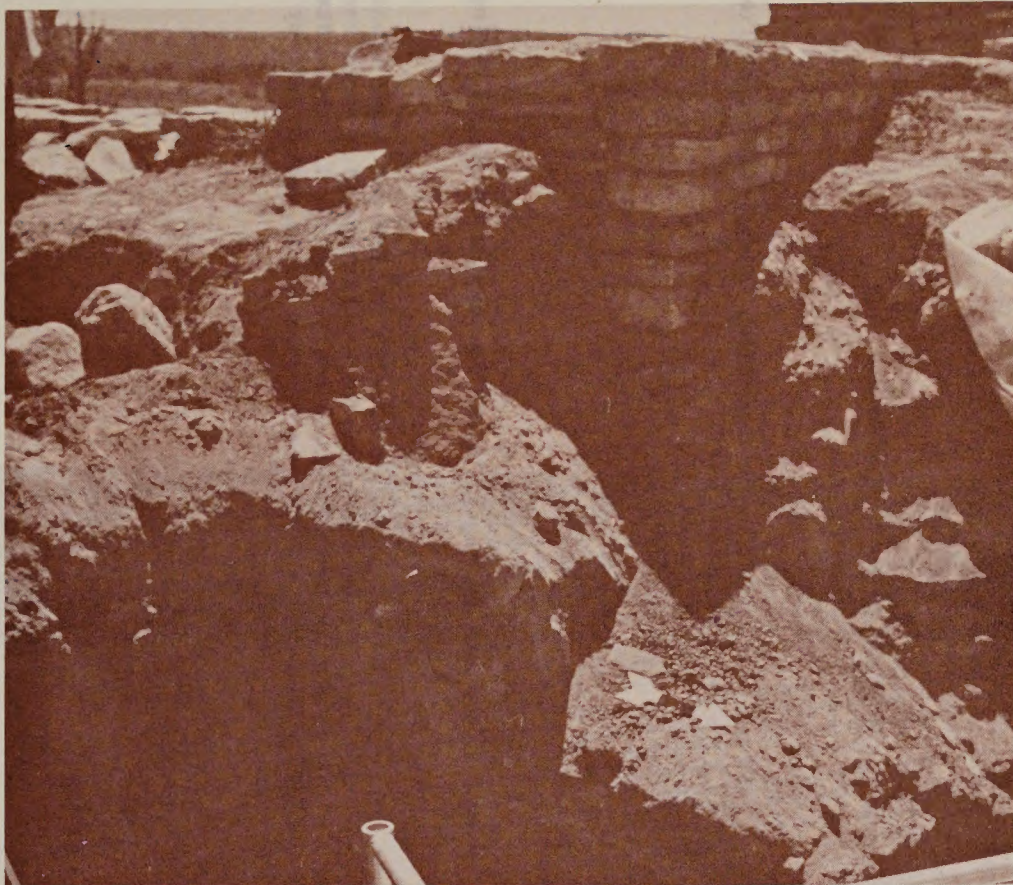
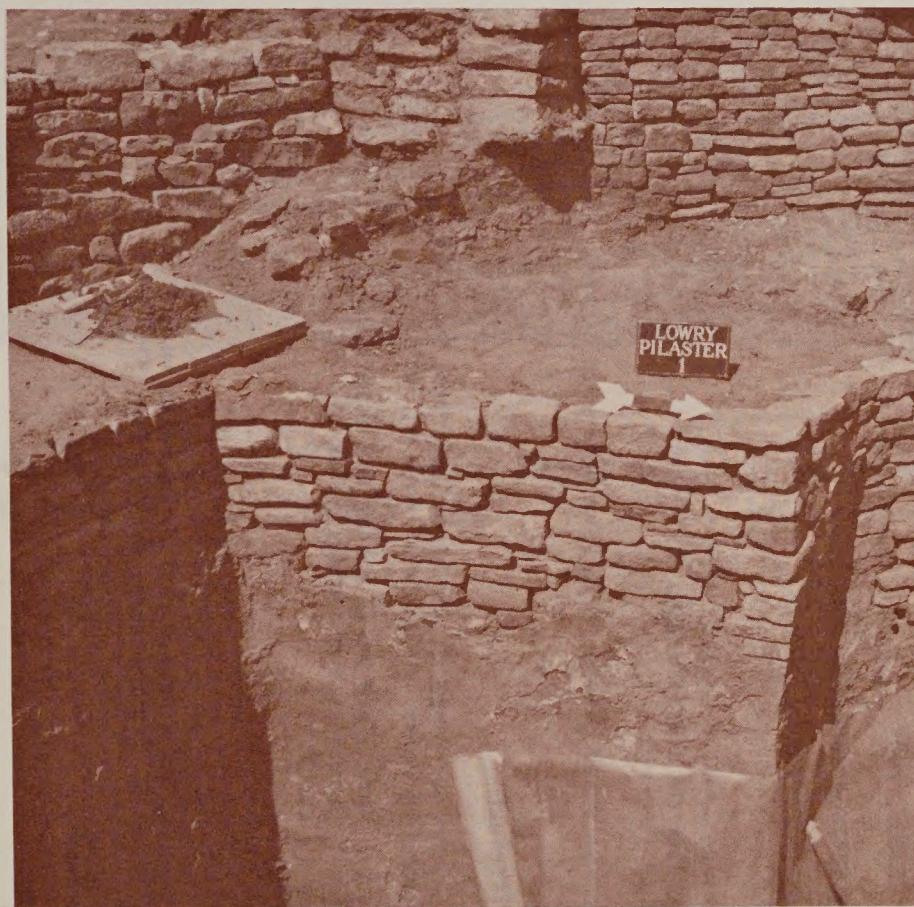
A large portion of the upper courses of Pilaster I were missing or partially eroded. Pilaster I needed to be rebuilt the entire thickness of pilaster from 40-86 cm. in height.

Figure 68. Kiva B, pilaster 1. a, before stabilization; b, after stabilization.

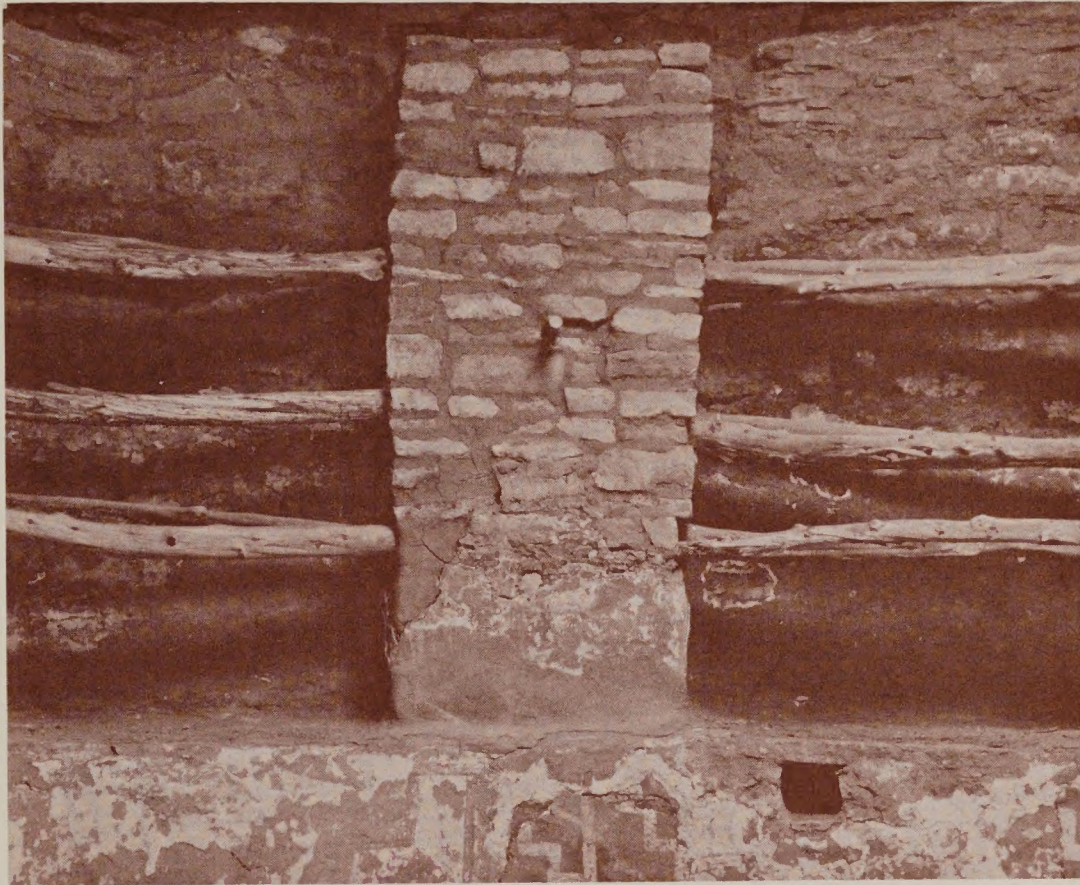
The prehistoric masonry of pilaster 2 was in very poor condition through the entire thickness of the pilaster. Building stones to a depth of 100-105 cm. needed to be removed from top of pilaster and reset.

Figure 69. Kiva B, pilaster 2. View after stabilization. No photo was taken before stabilization.

Pilaster 2 was taken down to a depth of 100-105 cm. and all loose stone and mortar were removed. Building stones were reset with a mixture of 3 parts Portland cement Type I and II and Shiprock sand. A new peg approx. 1 inch in diameter by 11 cm. in length was set in the front of pilaster in socket left by prehistoric peg.

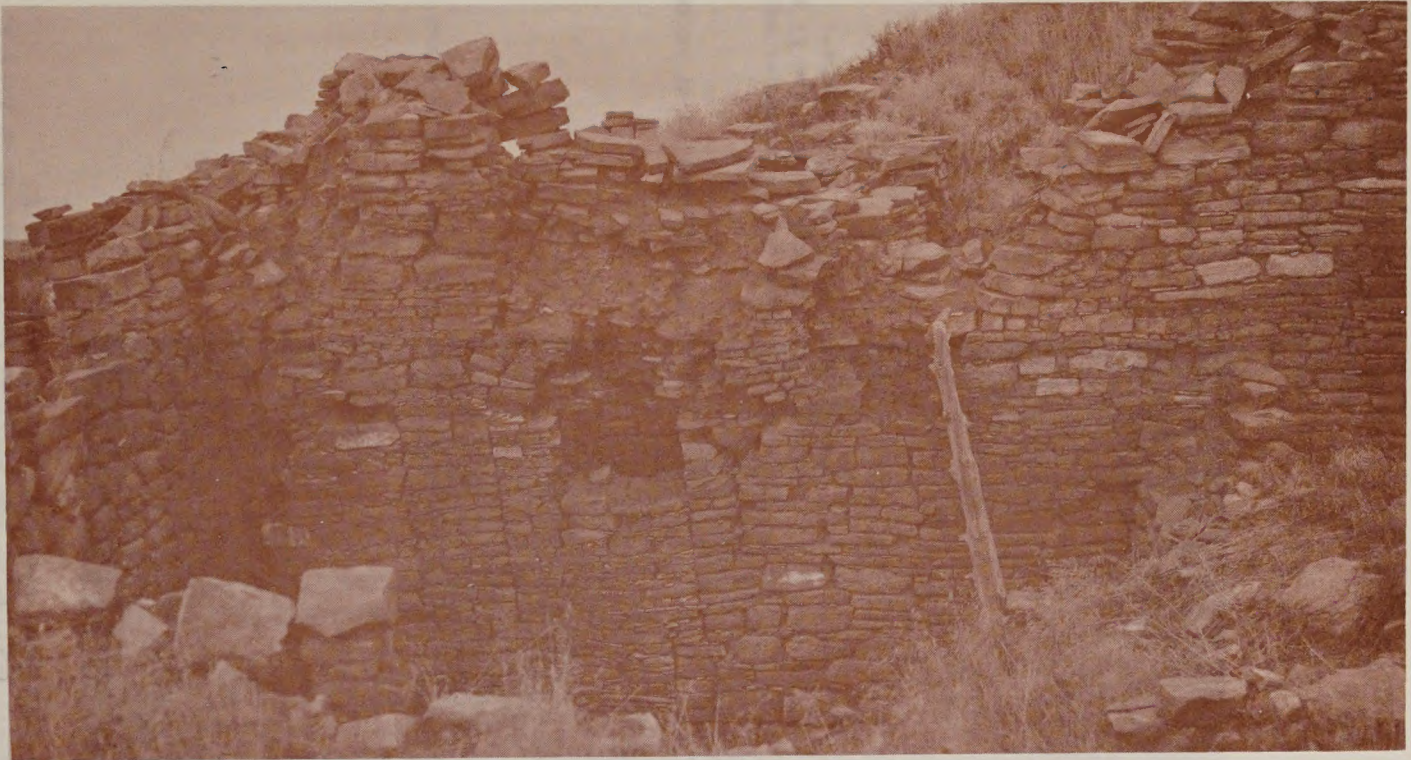
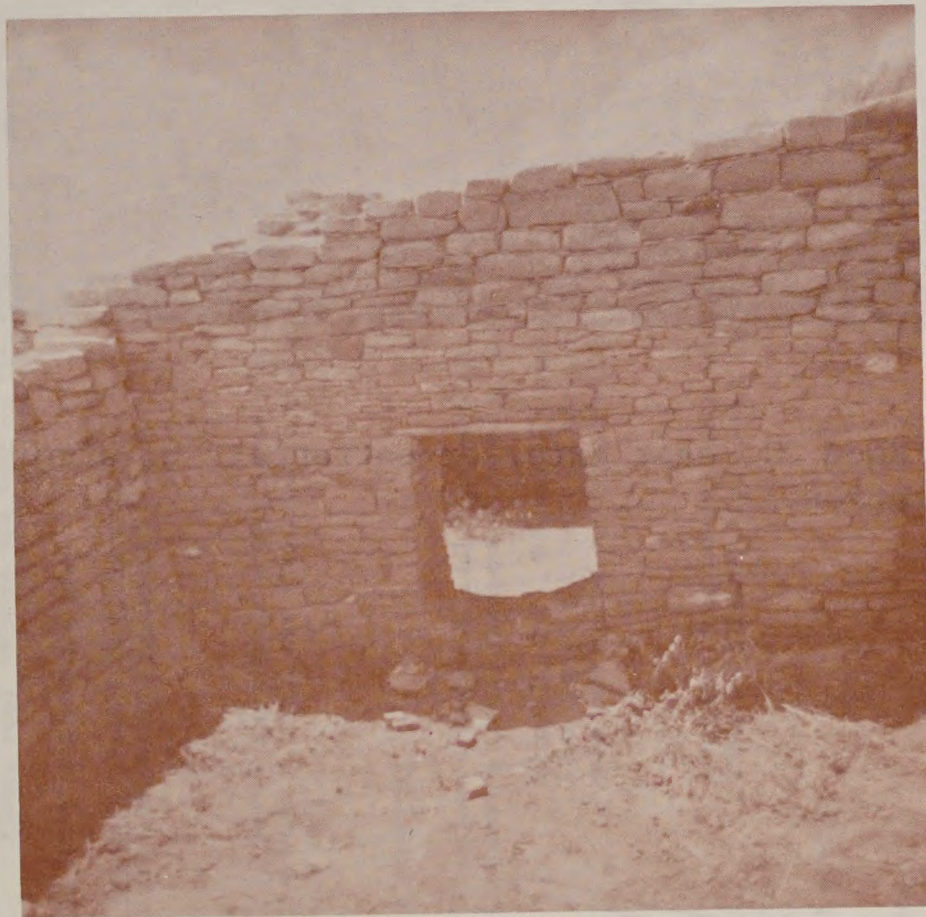
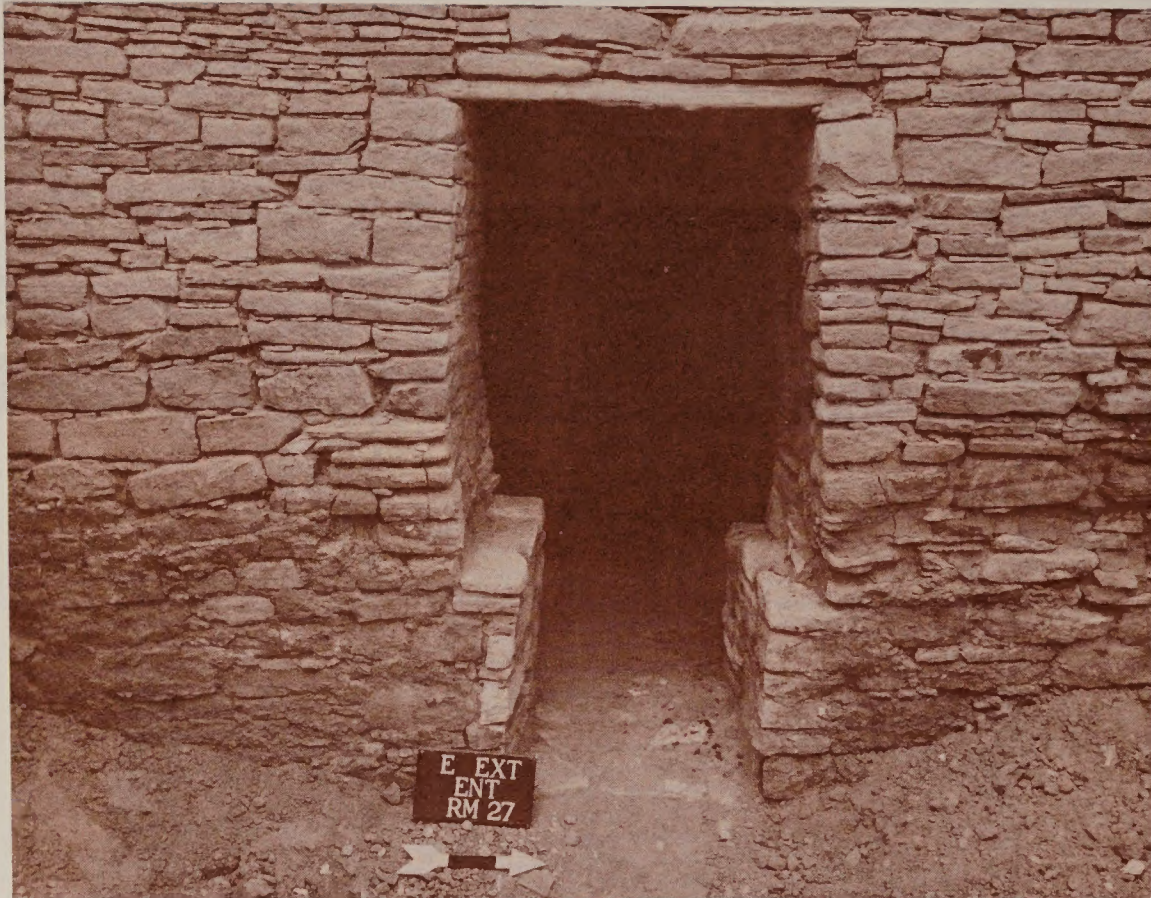
Figure 71. Room 27, east exterior entrance. a, entrance before stabilization in 1965; b, after stabilization in 1965 room was filled to above "T" of doorway.

Figure 71. Room 27, east exterior entrance. c, after excavation and stabilization.

Lintels of doorway were replaced in 1966 by Al Lancaster and crew. This report primarily covers the replacement of step.

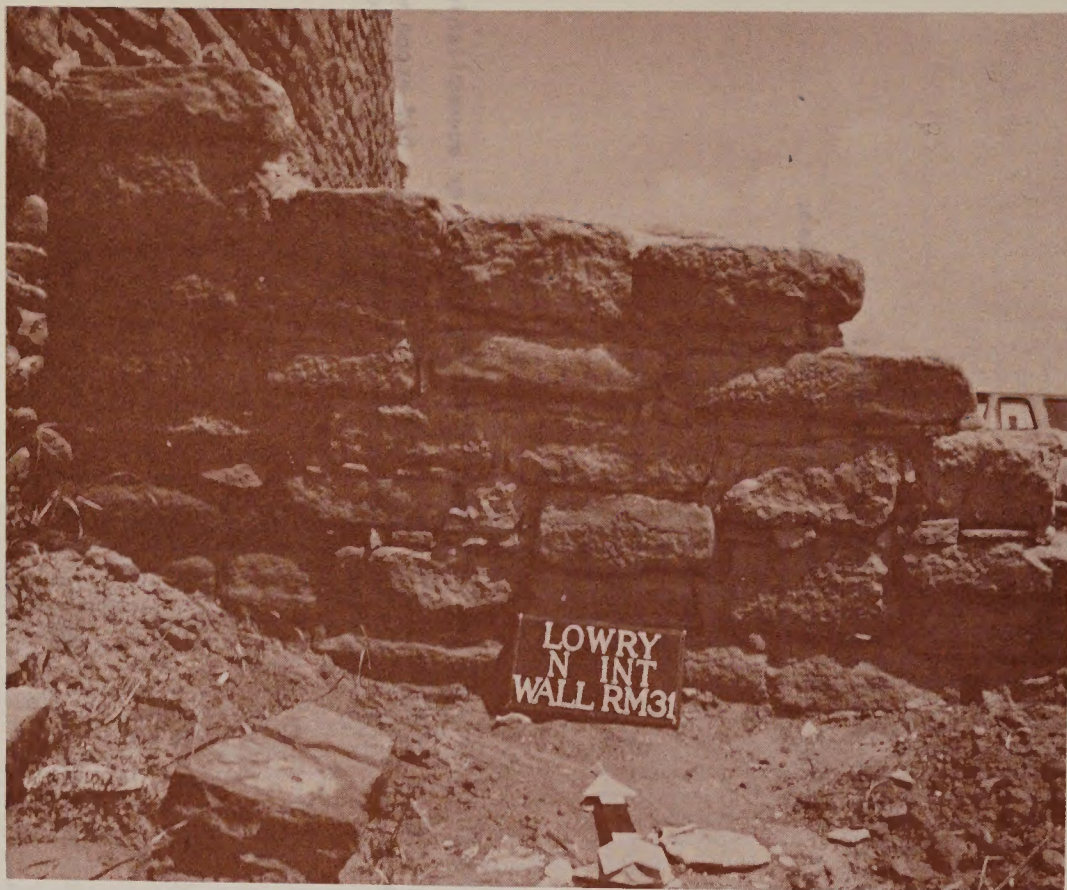
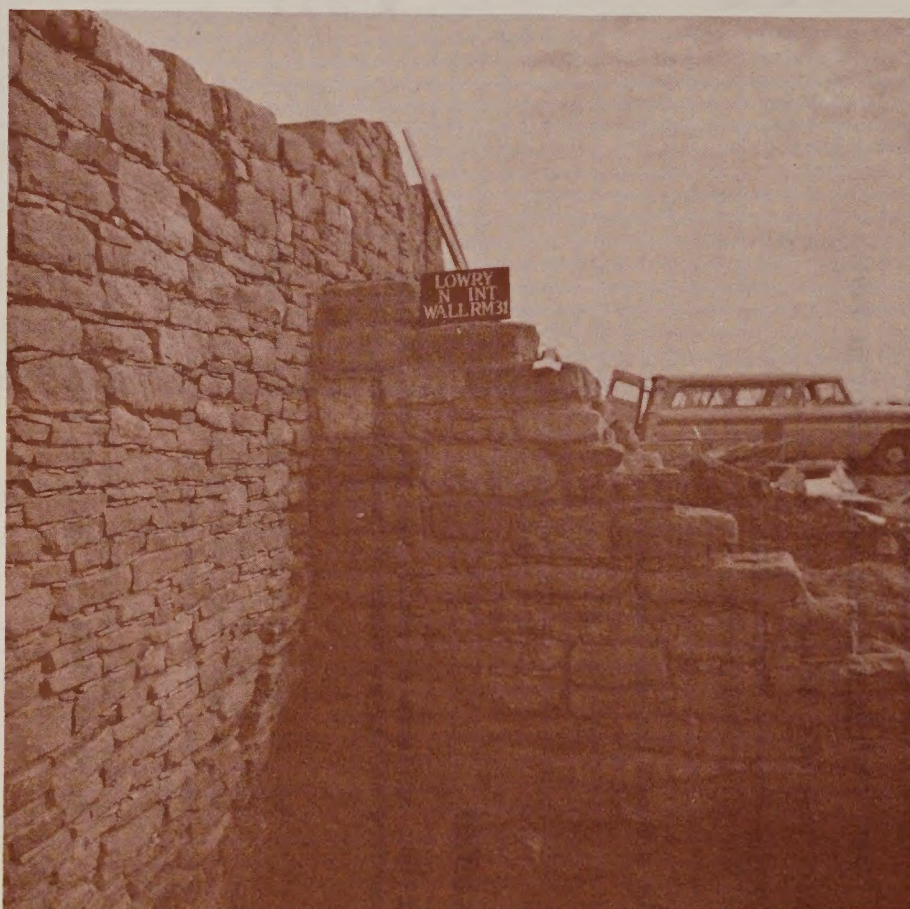
Figure 73. Room 31, north interior wall. a, before wall was stepped up as a brace to the west wall; b, after stabilization.
